Manhole Inspection Summary

Manhole # S53Q__016MH

Insp Date: **11/5/08 12:58 PM**

Location Address: **s. ellwood ave**

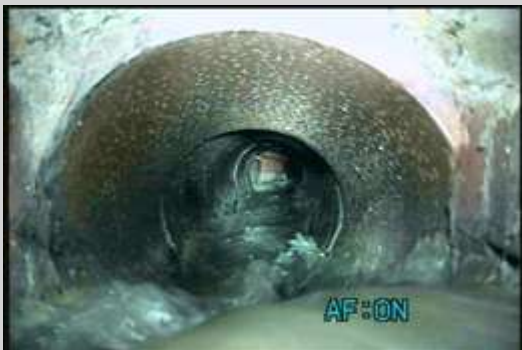
12 O'Clock Outflow

12 in. Circular Gravity Sewer
Pipe Out @ 12 O'Clock

Pipe Material: **Clay** ☐ Pipe Lined

Invert Depth: **15.46** (ft.) Flow Characteristics: **Fast**

Deposits: ☒ None ☐ Mud ☐ Sludge ☐ Debris ☐ Grease

Infiltration: **None** Pipe Seal Cond: **Unknown**

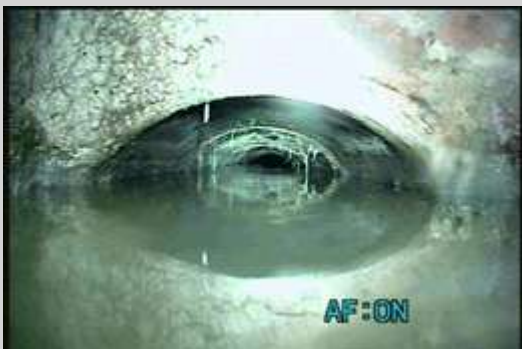
6 O'Clock Inflow

12 in. Circular Gravity Sewer
Pipe In @ 6 O'Clock

Pipe Material: **Clay** ☐ Pipe Lined

Infiltration: **None** Pipe Seal Cond: **Unknown**
